GUIDE TO REDUCE ROAD FAILURES IN WESTERN OREGON

Edward R. Burroughs, Jr.
George R. Chalfant
Martin A. Townsend

August 1973

Bureau of Land Management
Oregon State Office
P.O. Box 2965
Portland, Oregon 97208

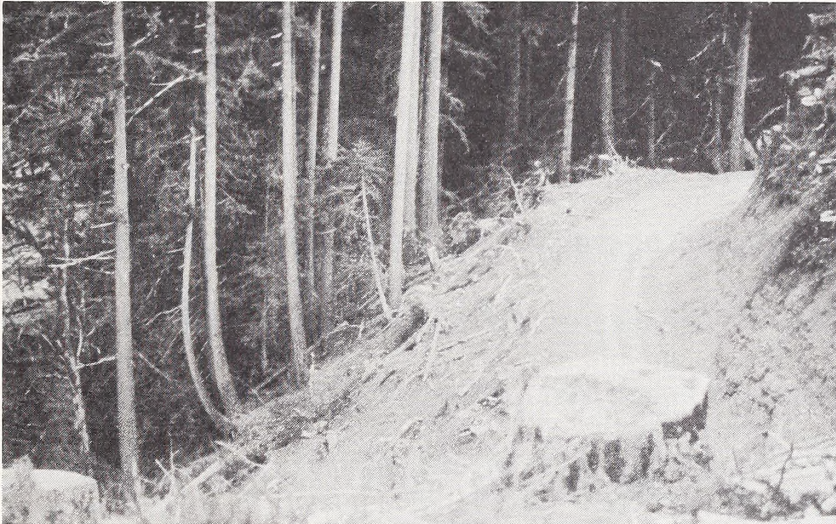
Figure 58 (left). Pistol-butted trees may be used as an indicator of active soil movement when the trees were young

Pistol-butted trees (Figure 58). These trees were tipped downslope while small as a result of sliding soil or debris, or as a result of active soil creep. As the tree grew, the top regained a vertical posture. Note, pistol-butted trees may indicate slope instability on other areas throughout western Oregon, but it should be kept in mind that deep, heavy snowpack at high elevations, such as the High Cascades, may also cause this same deformation.

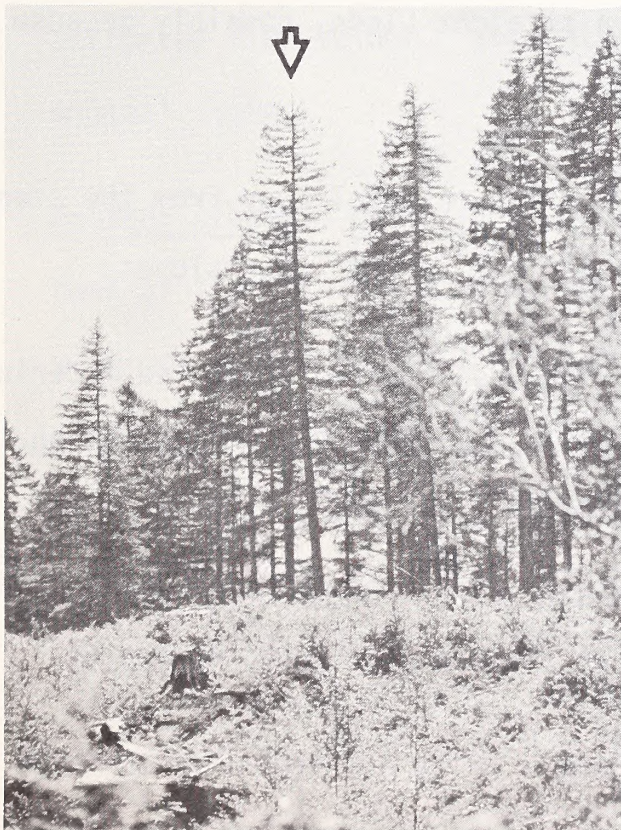
Figure 59. Tipped trees have a sharp angle in the stem.

Tipped trees (Figure 59). These trees have a sharp angle in the stem. This indicates that the tree grew straight for a number of years until a small shift in the soil tipped the tree and the angled stem is the result of the recovery of the vertical attitude.

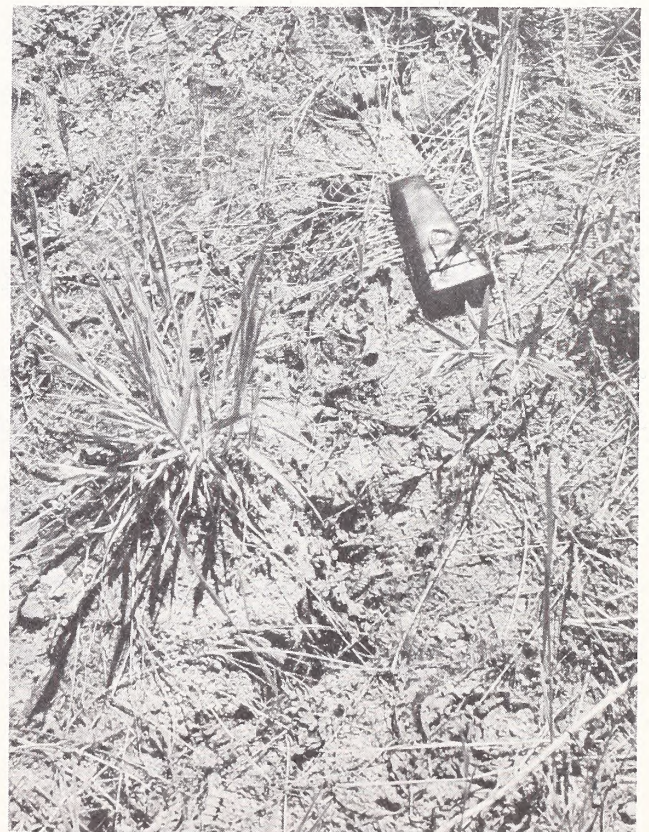
Figure 60. Tension cracks may be hard to find, but they indicate active soil movement

Tension cracks (Figure 60). Soil creep builds up stresses in the soil mantle which are sometimes relieved by tension cracks. These features may be hidden by vegetation but they definitely indicate active soil movement.

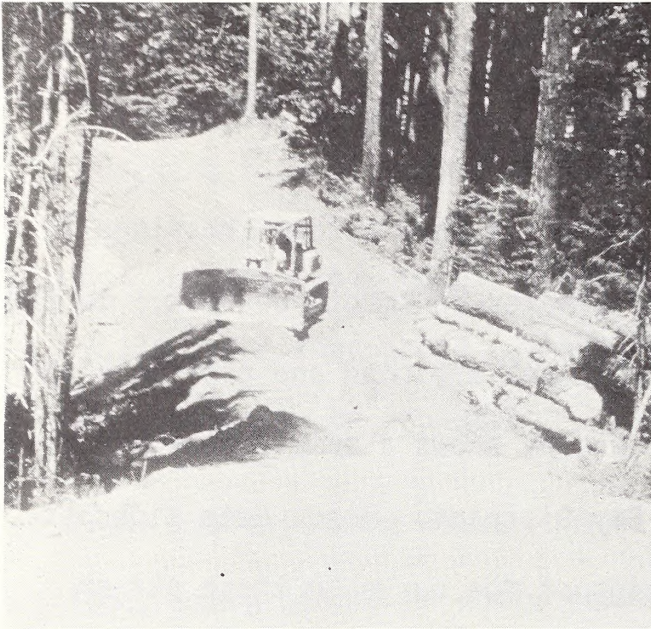
Figure 61. Endhailed material may be compacted on flattened ridges.

Fill saddles. Narrow saddles may be used to hold endhailed material by first excavating narrow bench roads below, and on each side of the saddle. The saddle may then be flattened and the loose material that rolls down-slope will be caught by the benches. Endhailed material may be compacted on the flattened ridge to build up the grade (Figures 61 and 62).

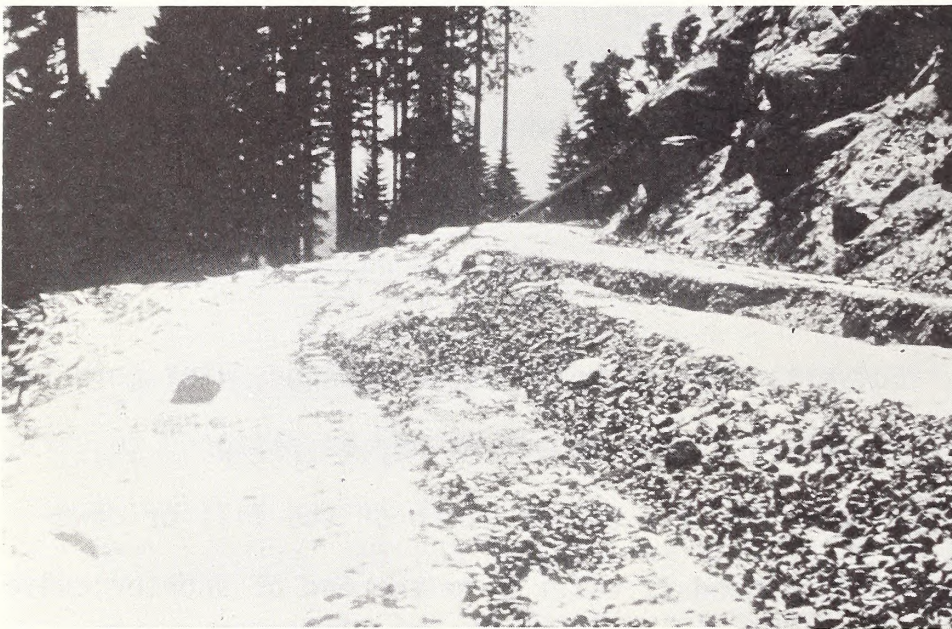
Figure 63 (left). A disposal site for endhailed material was located to the left of, and below, the road. Note the cracked and sunken grade.

Select safe disposal sites. Disposal sites for endhailed material should be chosen with care to avoid overloading a natural bench or spur ridge and causing slope failure (Figure 63). The closest safe disposal site

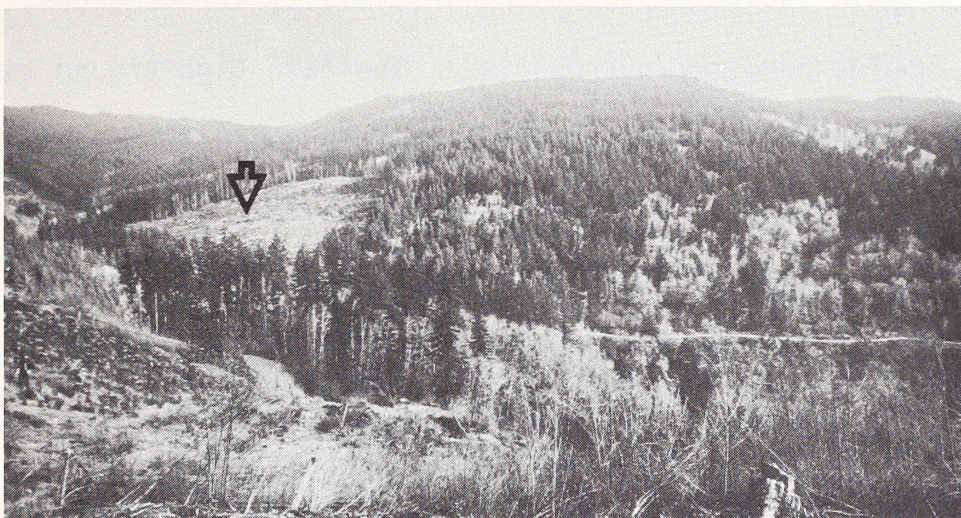
Figure 69. Terrain derived from weathered siltstone of the Nes-tucca formation. Note the hummocky slopes, the large slump in a clearcut area (arrow), and the hydrophytes on the hillside at the right of the photo.

The Nestucca formation contains considerable siltstone and the stability problem originates in the siltstone that is basically incompetent and easily weathered. Slumps and earthflows, both large and small, are very common when this material is subjected to heavy winter rainfall (as much as 100 inches in the Nestucca River basin). The slopes may exhibit a benchy or hummocky appearance and slopes with gradients as low as 24 percent may be considered to be unstable in deeply weathered siltstone with abundant ground water. Many of the higher ridges in the Nestucca formation are composed of intrusive volcanic rock and the siltstone forms the easily eroded basins bounded by the harder material. Bear Creek drainage, a tributary of the Nestucca River, contains examples of these stability problems (Figure 69).

Vegetative and topographic indicators of slope instability are numerous. Large patches of alder, maple, or other hydrophytes^{1/} indicate high ground water levels and impeded drainage (see the large patch of alder and big leaf maple in Figure 69). Conifers may be caused to tip or lean by earthflow or soil creep. Slumps cause numerous benches, some of which show sag ponds (Figure 71). Blocks of soil may sag and leave large cracks which gradually fill in with debris and living vegetation. The sharp contours of these features soften in time until these cracks appear as "blind drainages" or sections of stream channel which are blocked at both ends. These cracks collect water, keep the ground water reservoir charged, and contribute to active soil movement.

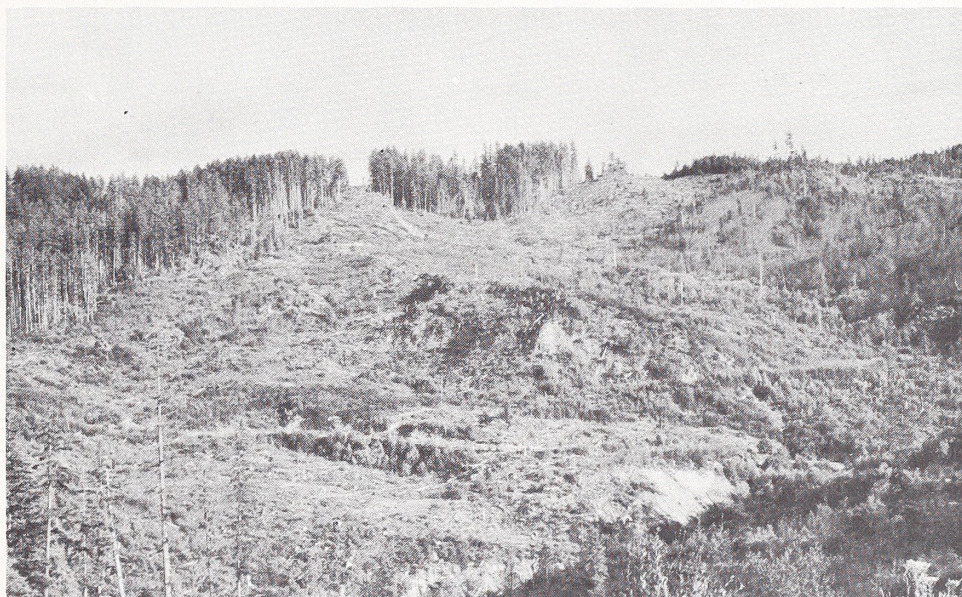
Figure 70. Terrain derived from the Otter Point formation. Note evidence of old slumps, and the recent slump in right foreground.

The Baker Creek area (Figure 70), a tributary of the South Fork of the Coquille River, illustrates these same stability problems in the Otter Point formation. Here, a relatively hard, dark sandstone (Figures 3f and 9) forms the boundary for the basins and the easily weathered siltstone causes slumps and earthflows similar to those in the Nestucca River basin. In Baker Creek, however, the situation is made even worse by the presence of scattered outcrops of serpentine.

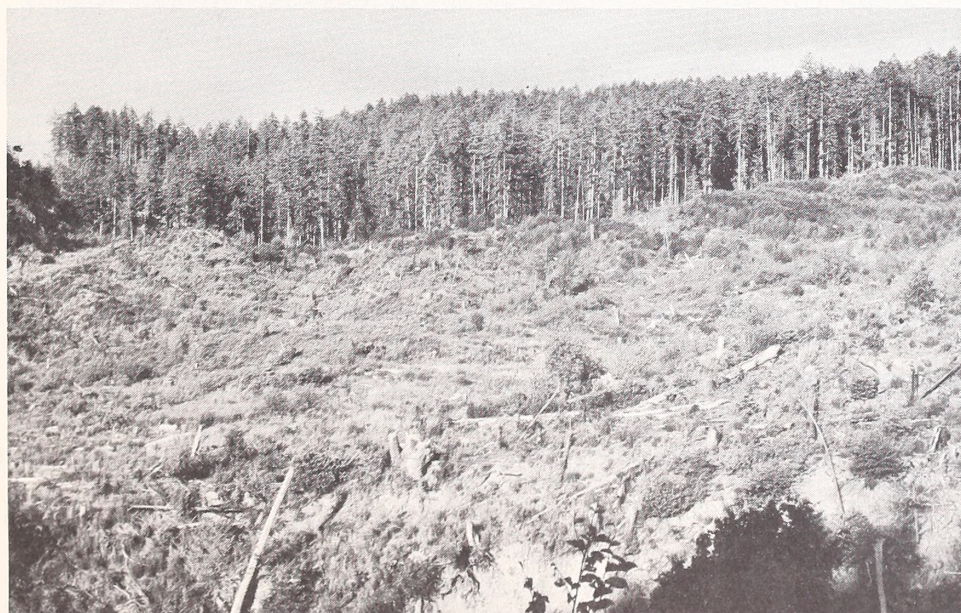
Figure 71. Benchy, hummocky terrain derived from weathered siltstone. Many of these depressions collect surface water and this causes continued earth movement.

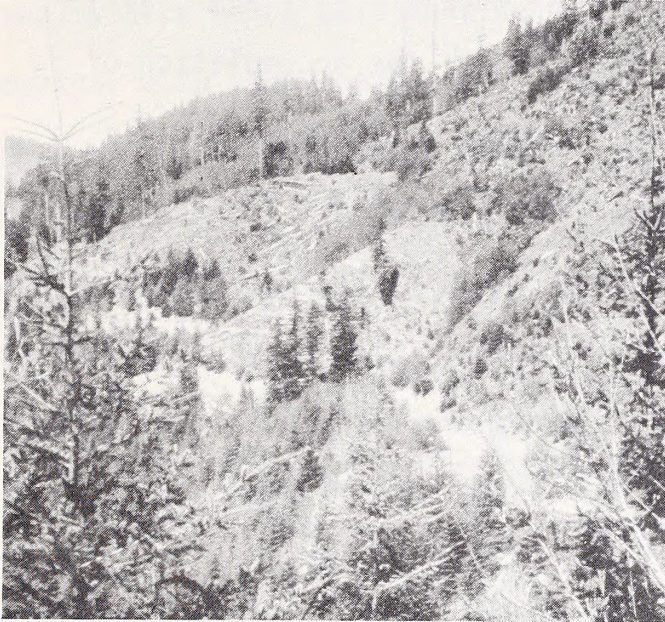
Figure 75. Sandstone ridgenoses on a slope of igneous rock.

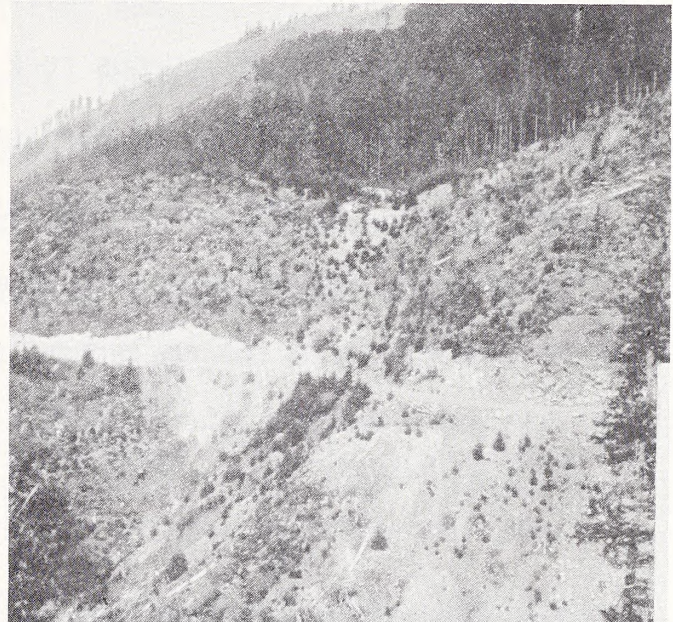
Figure 76. Contact zone between sandstone (l.) and igneous rock (r.).

material involved, and stability problems may be confined to the immediate contact zone (Figure 76). The arrow above A indicates the location of a debris avalanche which occurred since these photos were taken.

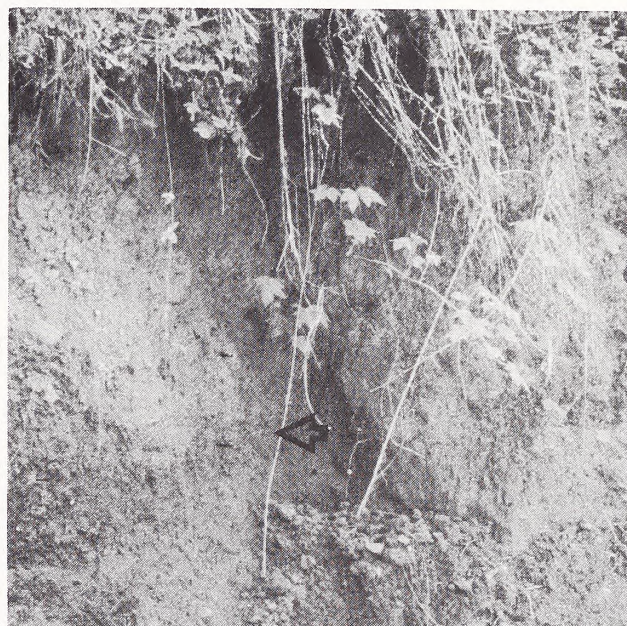
Figure 78. Arrow shows buried soil layer; pencils show springs.

the bedded sediments. While the rock itself may be quite stable, the material may weather into deep soils with a potential for slumps and earthflows. The upper slopes are frequently steep with shallow soils while the lower slopes usually have thick soil mantles as a result of erosion from the upper slopes together with deep weathering. These igneous rocks are relatively impermeable and subsurface flow moves rapidly downslope. Much of this ground water appears as springs at the upslope side of benches that are common along the streams in this terrain. The remainder of the groundwater seeps through the deep soils to the streams. Road cuts often expose soil layers buried as a result of ancient slope failures and ground water may move laterally along these zones and appear as springs in the cut face after road construction (Figure 78). These local wet spots are a frequent source of small slumps.

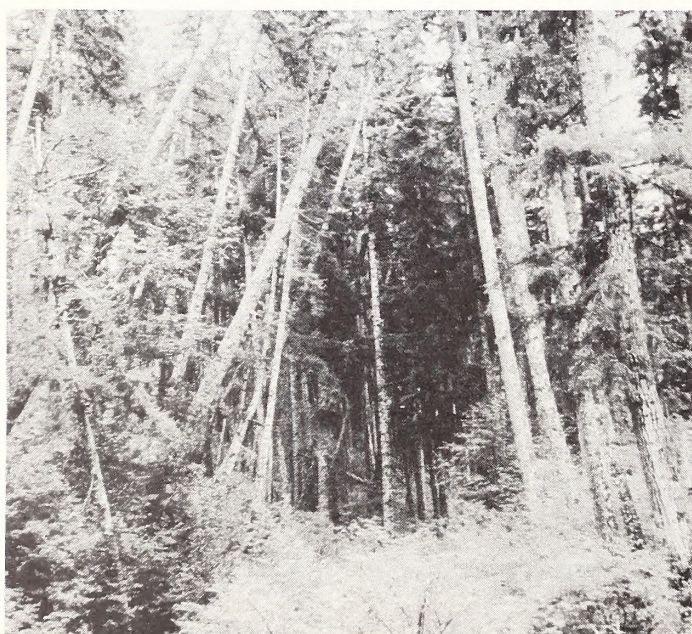
Figure 79. Indicators of ground water.

Massive slumps are often found on the landscape, and sag ponds and hummocky terrain tend to keep the ground water levels high in these areas. Tipped and jackstrawed trees, together with hydrophytes, are the vegetative indicators of abundant ground water (Figure 79). Other features of concern are the steep slopes between the benches and the streams. Erosion of the base of these slopes results in a gradual steepening of the slope with a corresponding

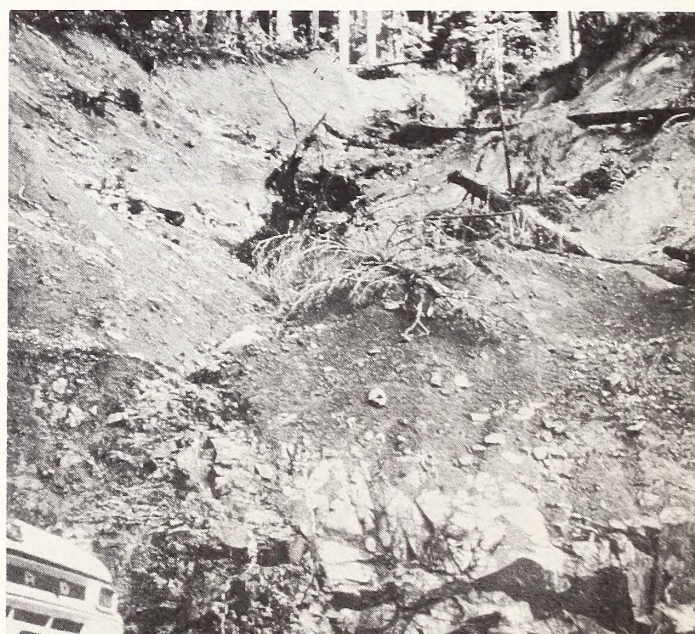
Figure 80. Pyroclastics over basalt.

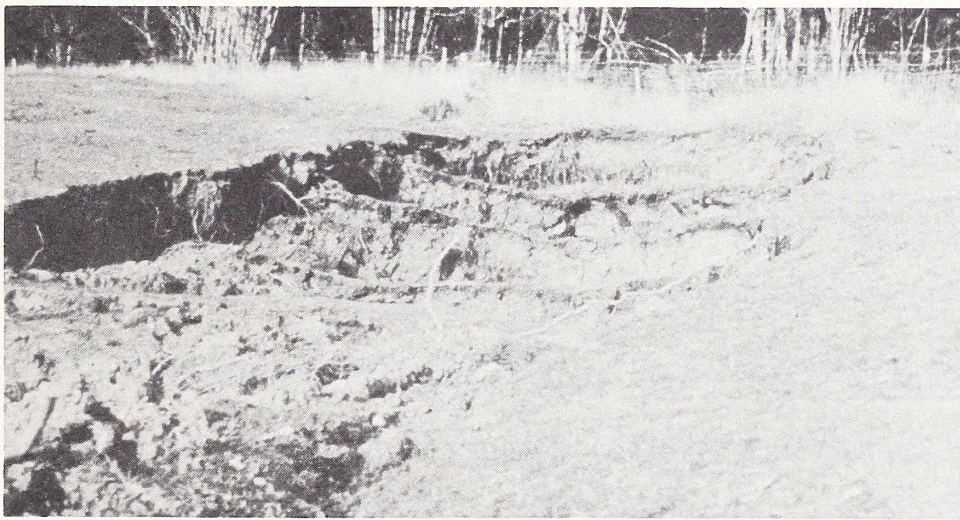
Figure 81. A progressive slump is a series of slope failures that may extend to the ridge top.

The "progressive" slope failure is another type of stability problem that is found frequently in deep soils on steep slopes in extrusive igneous material. This failure starts as an ordinary cut bank slump into a road. The removal of support causes failure of the next block of soil immediately upslope, and so forth, until there is a series of slumps one above the other that may extend to the top of the ridge (Figure 81). Ground water is usually abundant at these locations and engineers should be on the lookout for signs of an impending slope failure that could develop into a progressive slump.

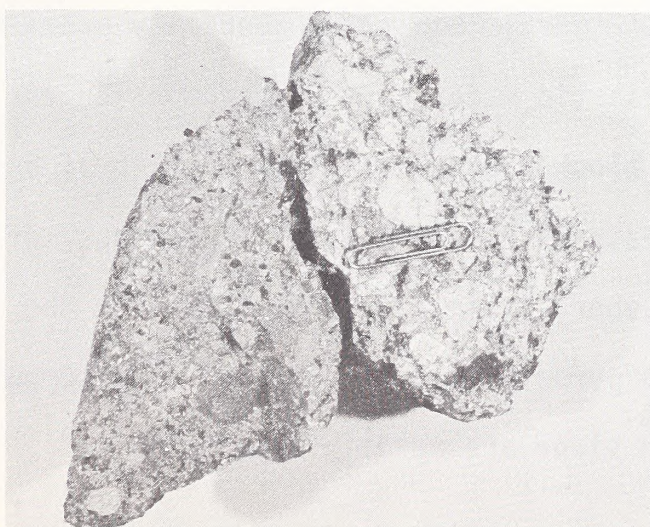
Figure 82. The color of pyroclastic materials may range from light green to dark reddish-purple.

Tuffs and breccias can come in a wide variety of colors which range from dark reddish-purple through light yellow to green (Figure 82). While all tuffs and breccias have marginal stability, the green variety is notoriously unstable. Soil and rock colors seem to provide a local field guide for prediction of the clay group and the relative landscape stability. Research by Paeth, et al., has shown that soils with montmorillonite clays have 2.5Y and 10YR color hues and have been derived from greenish rock. Relatively stable soils with 7.5YR hue have been derived from yellowish and reddish rock.

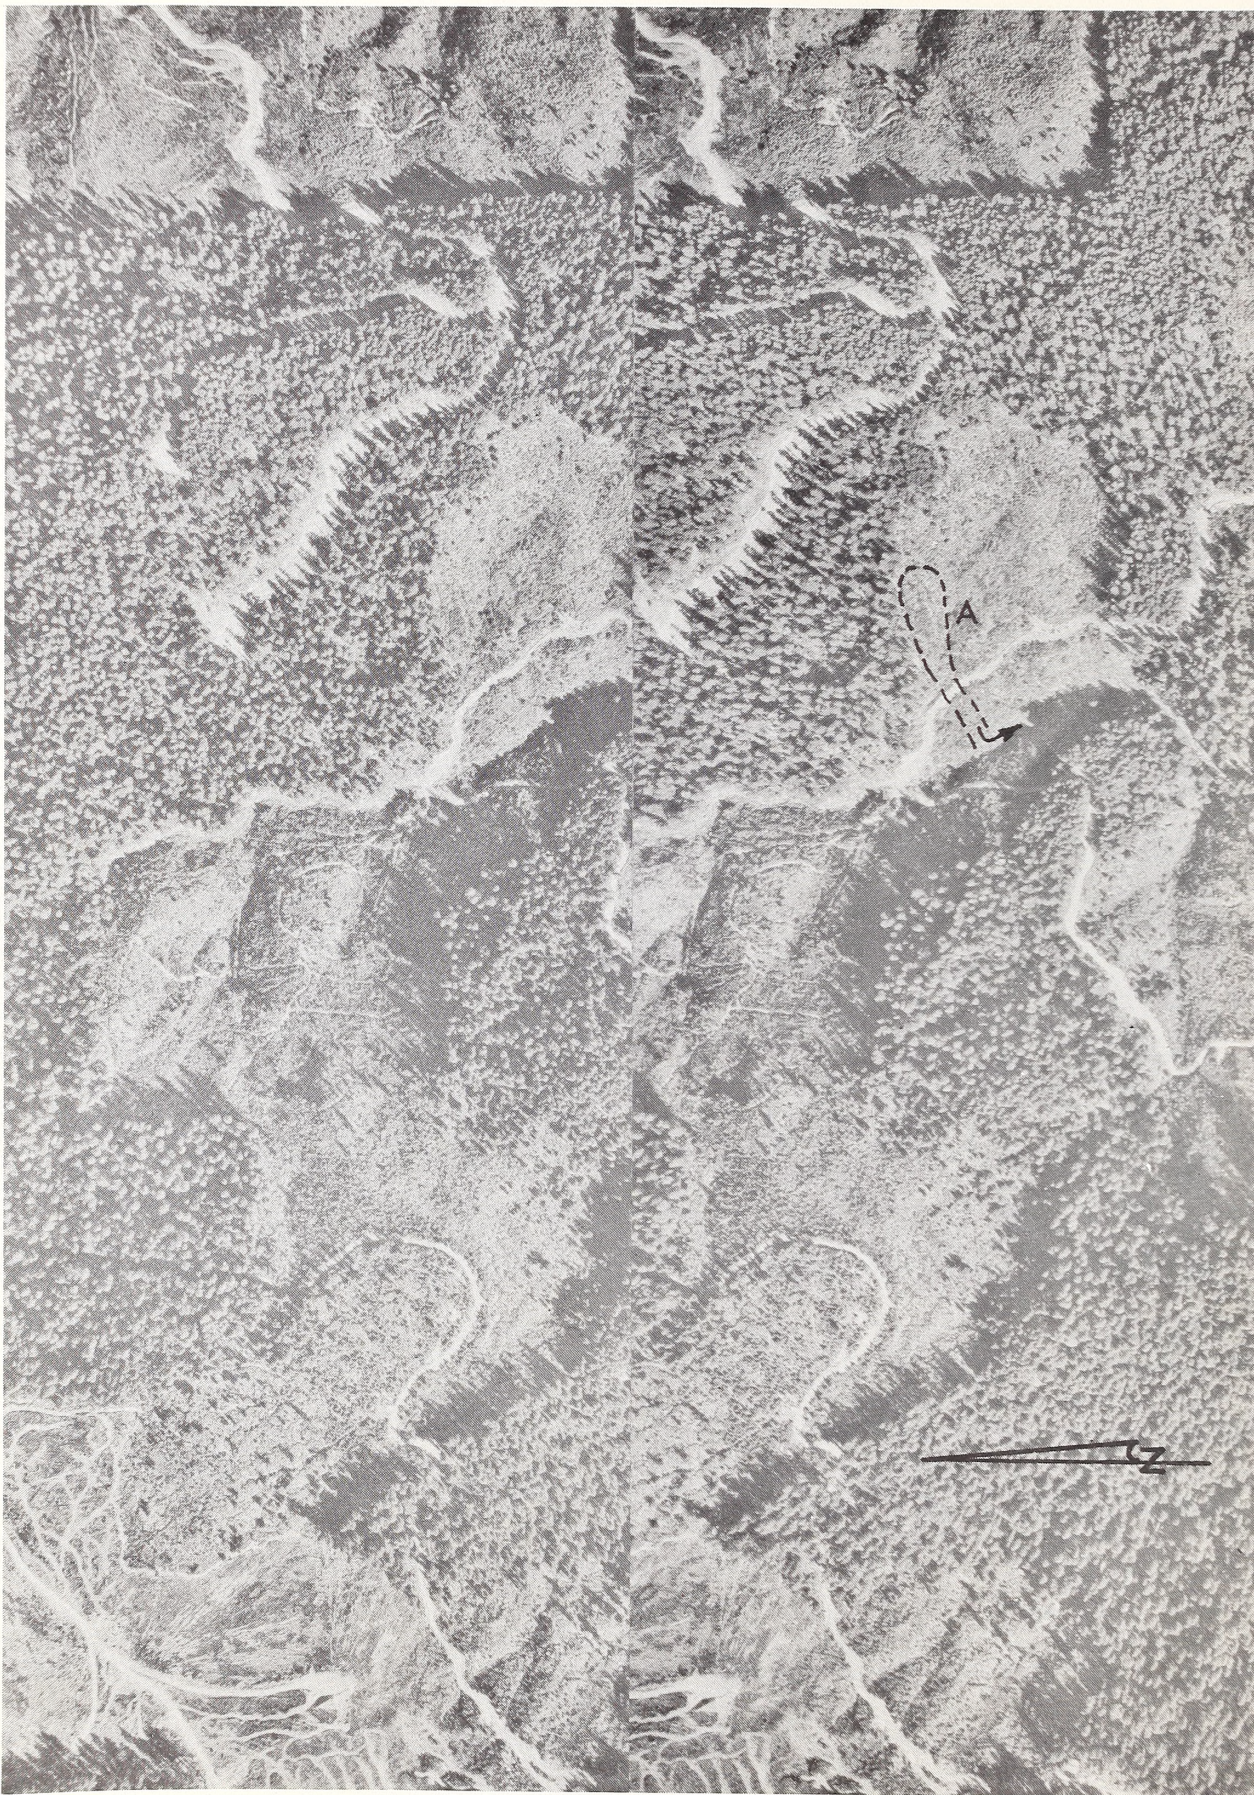
Figure 87. This stereogram shows unstable terrain derived from pyroclastic rock; there is evidence of active soil movement over the entire photo. An old slump is shown at point A and the dashed line outlines a new slump. Figure 88 shows a ground photo of this slump.

Whitcomb Creek, that flows into Green Peter Reservoir on the Middle Santiam River, is an excellent example of unstable terrain associated with pyroclastic rock. Figure 87 is a stereogram that shows an old slump at A. A depression can be seen at the base of the scarp above and to the left of point A. Whitcomb

Creek has steepened the slope below this old slump and excavation for the road has removed even more support. This basin failed by slumping after these photos were taken and debris flowed into the creek. The approximate boundary of the new slump is shown on the stereogram. Damage to Whitcomb Creek from the debris flow down the channel was reported to be severe. Figure 88 shows a portion of the new slump and the presence of ground water at the head of the slump is shown by the dark stain on the exposed bedrock.

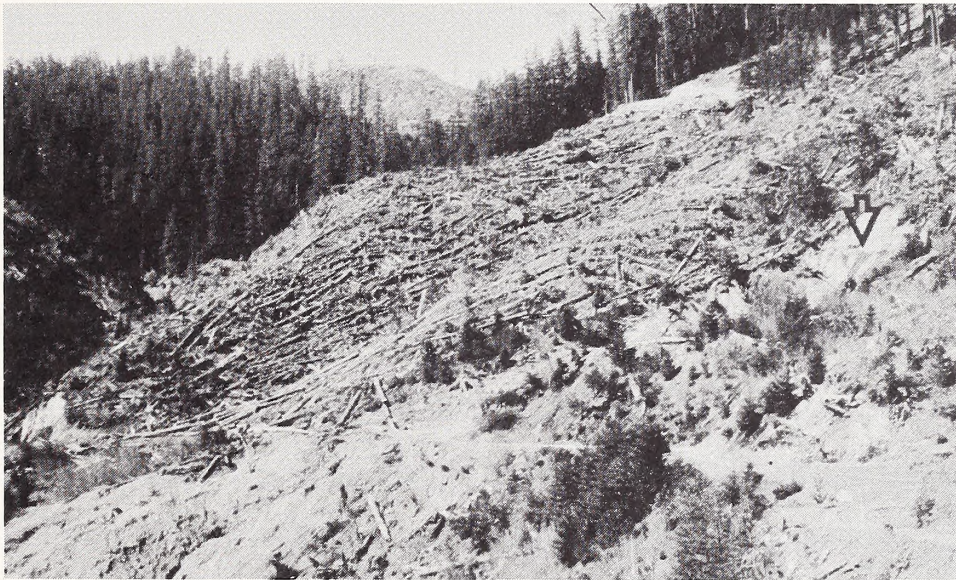
Figure 88. Ground photo of the new slump outlined in Figure 87. The arrow indicates ground water seeping from the face of the scarp.

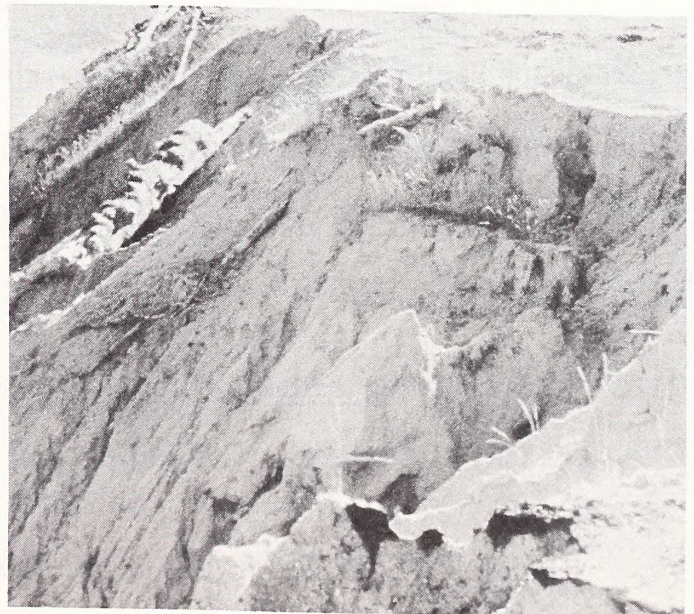
Figure 90. Granitic soils tend to be coarse-grained and very erodible as shown here.

Granitoid rock often weathers to a coarse-textured soil that may be low in clay if erosion is rapid. Those soils that develop in place for long periods may have a clay content of as much as 25 percent or more and may be relatively stable. Those soils that are low in clay have a single-grained structure with little cohesive strength that causes them to be easily eroded (Figures 89 and 90). It is these coarse-grained granitic soils that will be considered here.

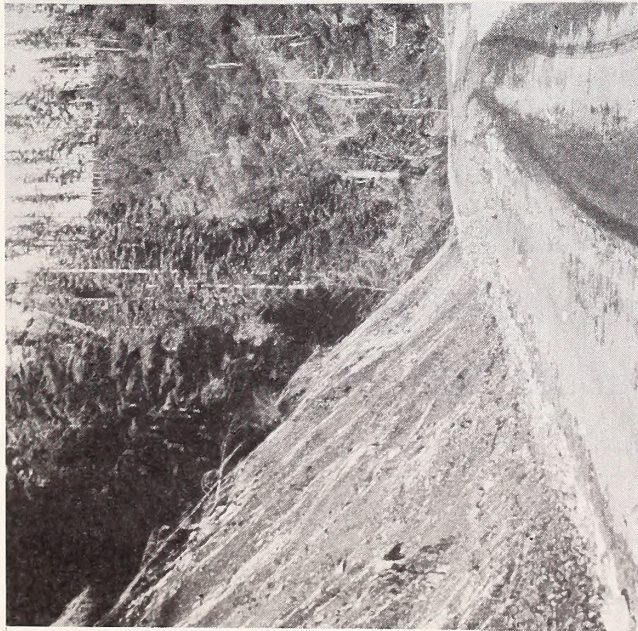
Figure 94. Rockfalls in deeply weathered schist. Note tipped tree.

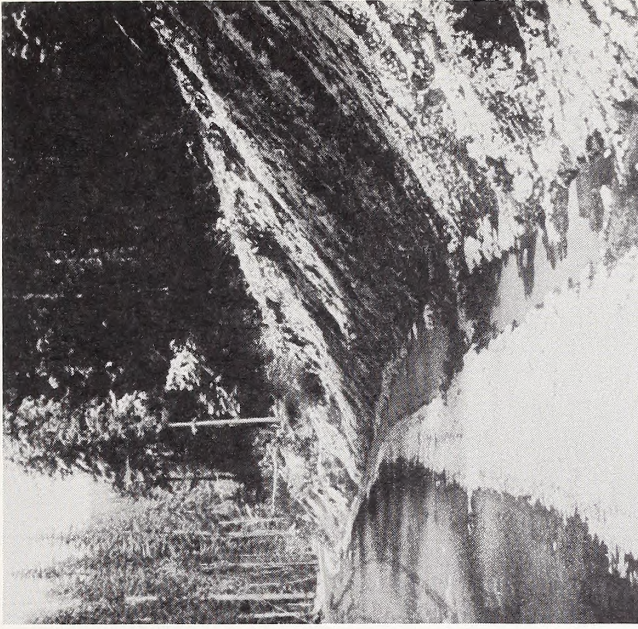
Figure 96. Small slumps cause impeded ditch drainage.

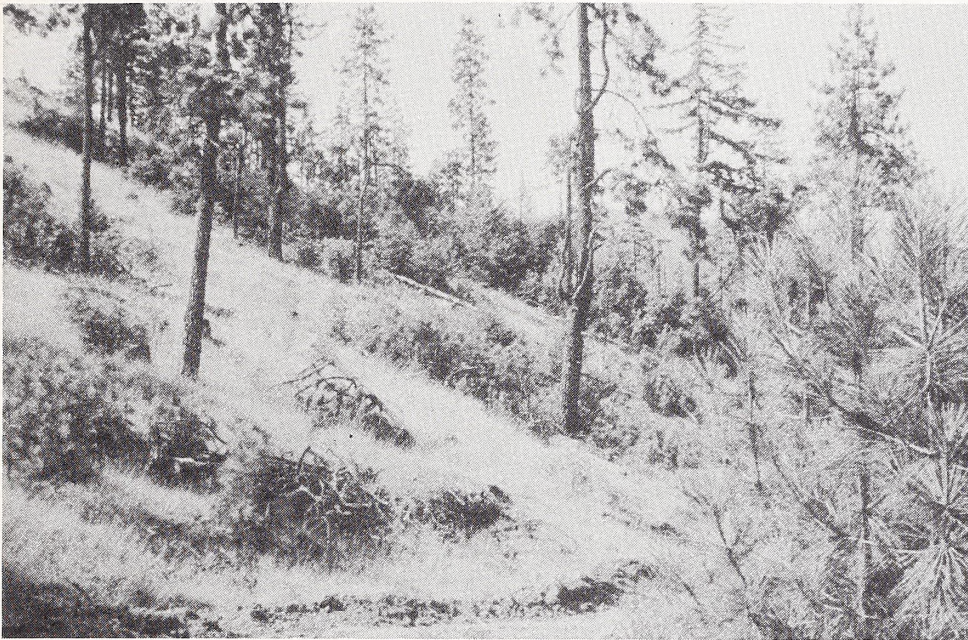
Figure 98. Sparse stands of Jeffrey pine often indicate the presence of serpentine bedrock.

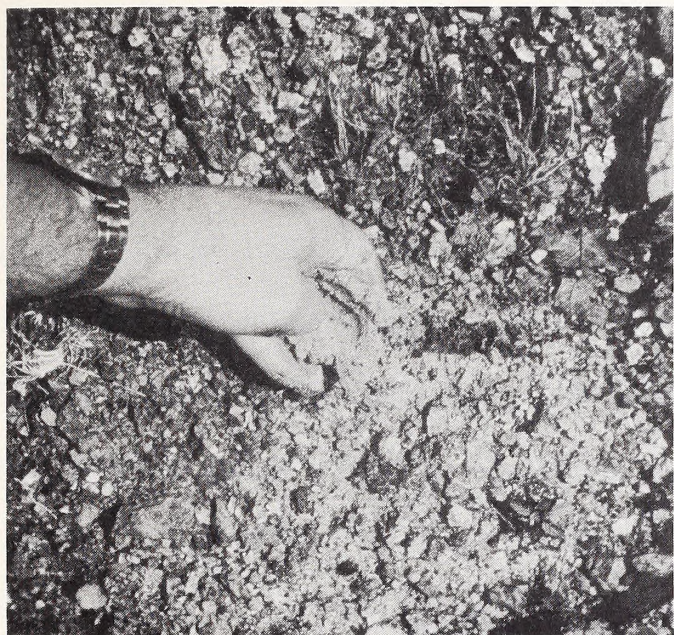
Figure 100. Serpentine often weathers to a sticky clay.

Serpentine material behaves somewhat differently in the wet coastal climate. There is enough rainfall to cause rapid weathering of exposed serpentine to a sticky clay--often referred to locally as a "blue clay" (Figure 100). Small outcroppings of serpentine occur in other geologic materials such as the Dothan formation where vegetative indicators of serpentine may only be a grassy hillside (Figure 101). These grassy openings often show tension cracks and cat steps. Rock riprap for support of the cut bank and control of drainage water may be the only slope stabilization techniques that are possible when roads traverse small areas with serpentine soils. Care should be taken to distinguish between small serpentine outcrops and exposures of thin beds of dark siltstone within the Otter Point formation, the Dothan formation, and other minor sedimentary formations along the southern coast. These beds of siltstone may be tilted to a nearly vertical position, they may be deeply weathered, and they often slump and flow into the roads. These beds may be covered with the same vegetation that is on the surrounding terrain, but the weathered siltstone does not have the high clay content of the weathered serpentine.

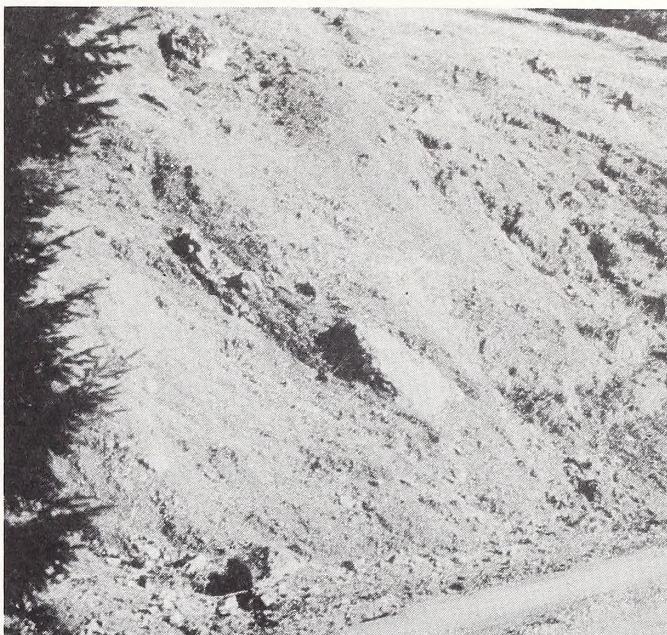
Figure 101. Grassy hillsides often indicate small serpentine outcrops.

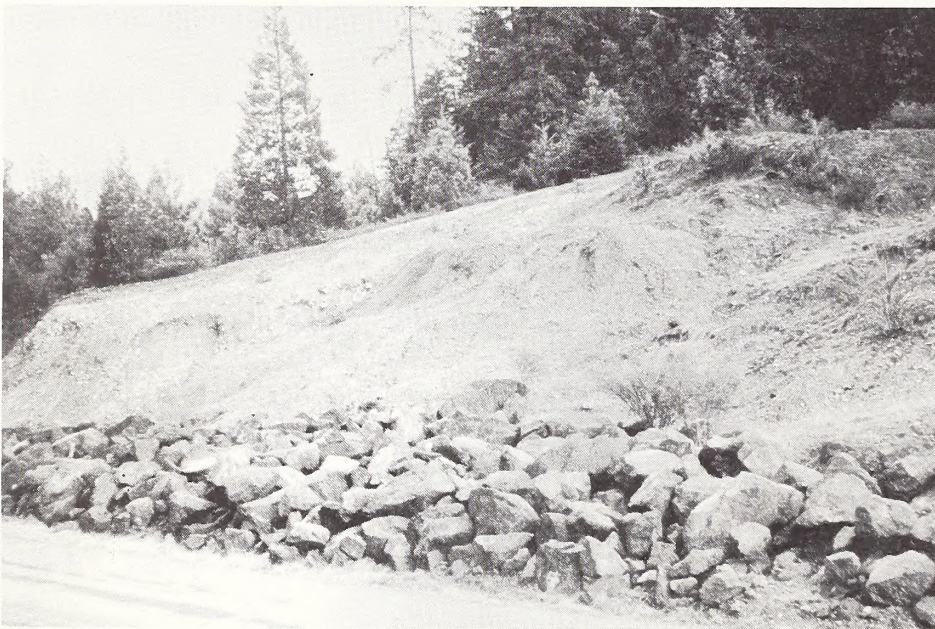
Figure 102. Heavy riprap may be used to support slumping embankments in serpentine material.

Embankment support. Be prepared to apply blankets of heavy riprap rock for slumping cut banks (Figure 102).

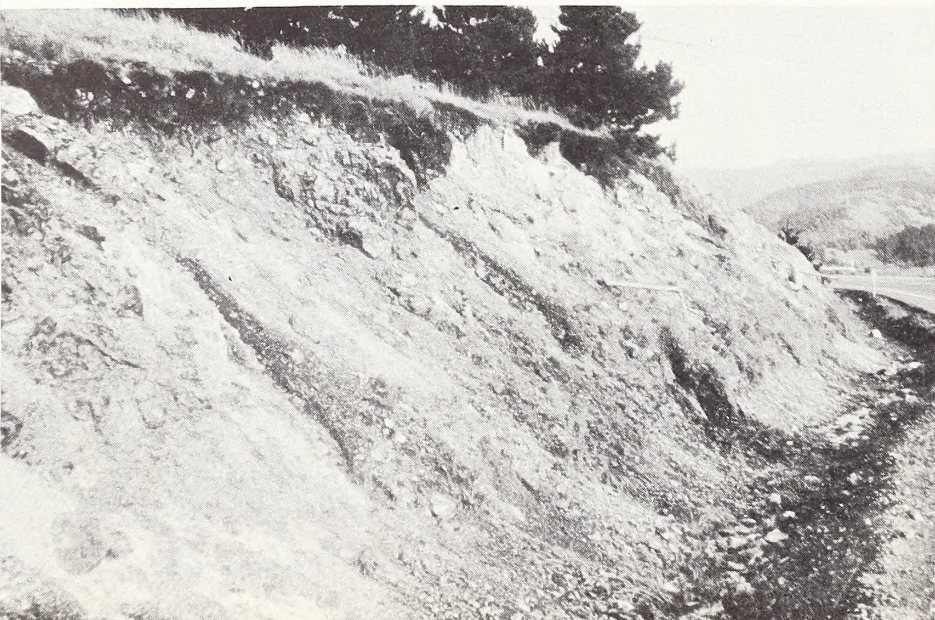
Figure 103. Perforated pipe may be needed to remove ground water from embankments in serpentine material. Note the volume of water issuing from the pipe at the right of center.

Ground water drainage. Be prepared to collect and dispose of ground water through extra drainage work as the magnitude of the ground water problems become evident as construction begins. This extra work may include perforated pipe in the cut bank (Figure 103).
